## **THE DESIGN OF FLOOD PROTECTION ALONG NAN RIVER, PHITSANULOK PROVINCE, THAILAND**

### **ABSTRACT:**

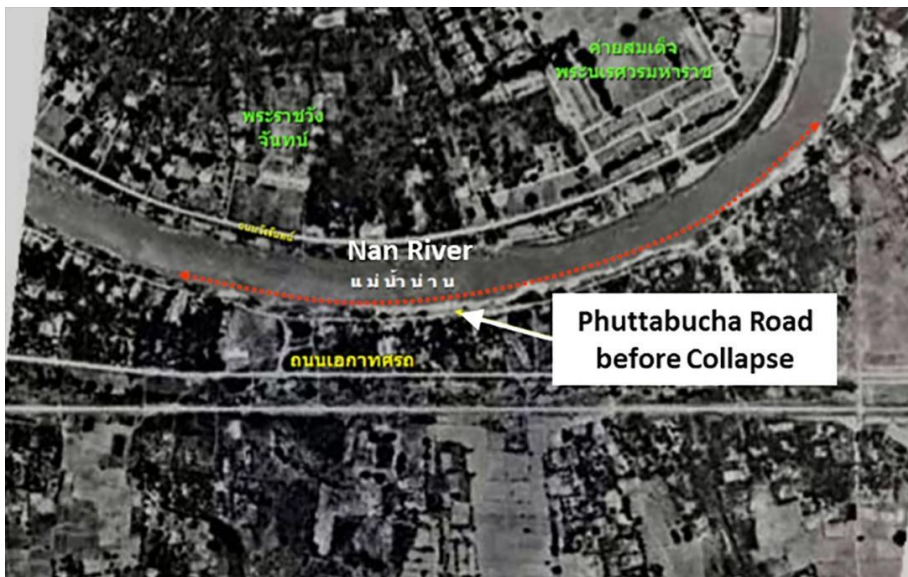
**Fig. 1.** Aerial photo of the studied site.

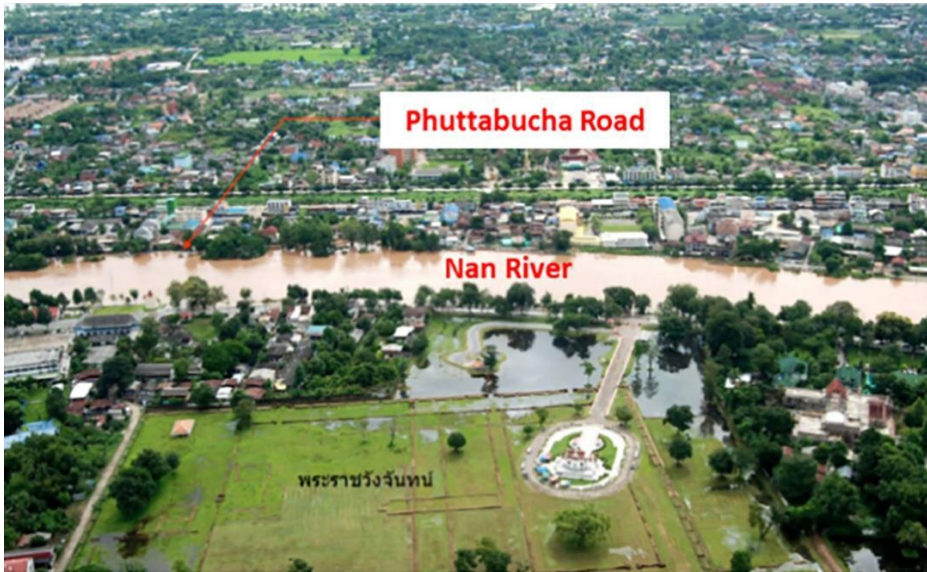
Fig. 2. The studied site in 2011.

Chao Phraya River is the most significant river of Thailand. It is the major river which conveys and distributes water to the agricultural areas located in the north and center of country (Chuenchooklin and Pangnakorn, 2015). The river is formed by the confluence of four rivers, which are; Ping, Wang, Yom, and Nan rivers. Phitsanulok is located approximately 400 km away from Bangkok, in the northern part of the country. Two important rivers flow through the Phitsanulok province. The Yom river enters the province in the north-western region from the Sukhothai province. On the other hand, the Nan river transports the water from the Nan province to Phitsanulok province via the Phare and Uttaradit provinces. The two rivers later join and form a single branch at the Pichit province, which located below the Phitsanulok province. In the centre district of the Phitsanulok province, the erosion of Nan river is one of the most anxious issues of the urban communities. The riverbank erosion causes the loss in private and public assets every flooding season. The municipality and community constantly work hard to control the flooding and river erosion along the Nan riverbank. **Fig. 1** illustrates the aerial photo of the studied site in the past. The figure demonstrates the existence of public road before it collapsed by the river erosion. The Phuttabucha road appears in **Fig. 1** was continually destroyed by the river erosion and flooding events. **Fig. 2** shows the aerial photo of the studied site during the flooding event in 2011.

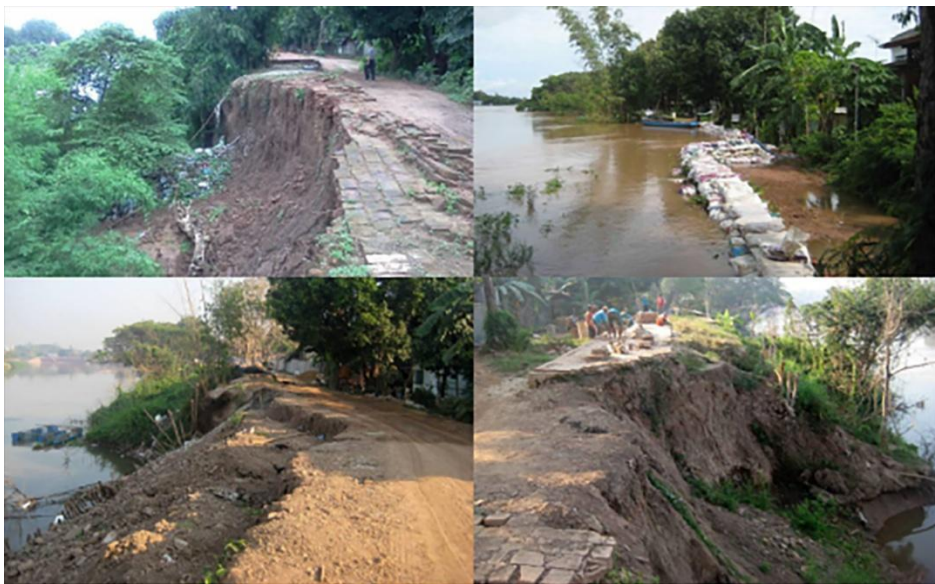
Fig. 3. Consequences from the river erosion and flooding event in 2011.

The flooding event in 2011 has brought concerns to the communities. **Fig. 3** displays the consequences of river erosion and the flooding events along the riverbank. The ancient city walls along the riverbank were severely destroyed as shown in **Fig. 3**. The 500 year-old city walls with the embankment width of approximately 15 m were tremendously suffered from the flooding event in 2011.

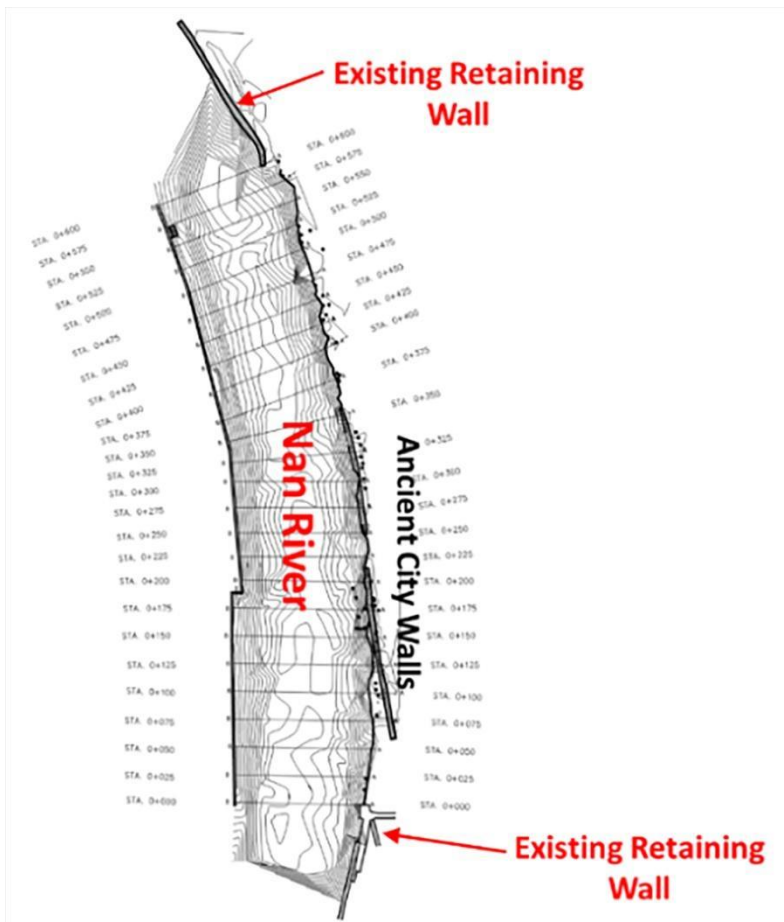
**Fig. 4.** Topographic map of the studied area.

The main aim of the project is to provide the effective flood protection and river erosion mitigation systems to the Phuttabucha community. In the early stage of the project, the fundamental information for the mitigation system design was gathered. **Fig. 4** illustrates the topographic map of the studied area. The soil investigation program was also conducted to collect the index and engineering properties of soil. The water level history was investigated and would be used for assigning the appropriate geometry of the mitigation system.

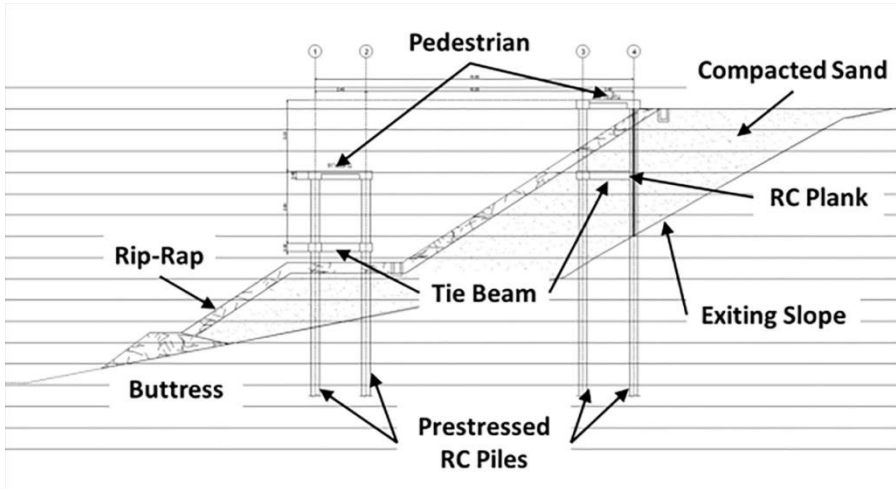
The first alternative mitigation system is presented in **Fig. 6**. Four rows of Reinforced Concrete (RC) pile were installed to prevent the global failure of soil slope along the riverbank. The river erosion is prevented by the rock rip-rap laid on the slope surface; while the retaining wall with RC plank was designed to protect the communities from flooding events.

Fig. 6. First mitigation system.

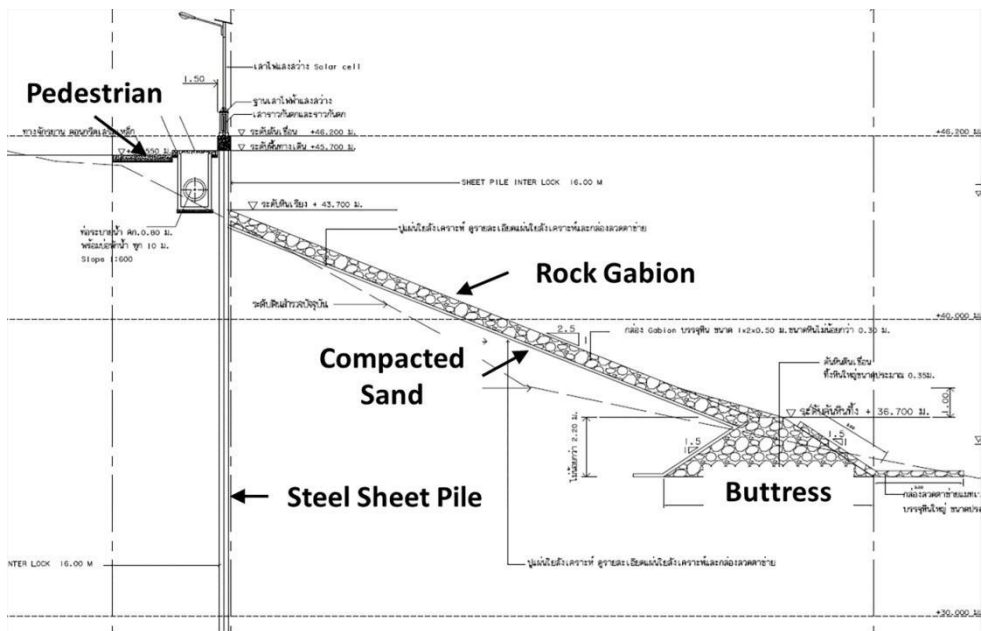
**Fig. 7** shows the second alternative mitigation system in the project. The global failure of soil slope along the riverbank is prevented by the continuous sheet-pile wall. The rock gabion was designed for controlling the river erosion in this 2nd scheme. Rock gabion is a wire-mesh cage filled with rock (Bergado et al., 1996). Presently, the rock gabion is popularly used in Thailand for the river erosion control (Bergado & Soralump, 2003) because the gabion is inexpensive and it can be installed easily on the slope face.

Fig. 7. Second mitigation system.

The discussions during the public hearing event and the internal meeting with municipality led to the selection of second alternative as the designed mitigation system. Although, construction cost of the 2<sup>nd</sup> scheme is higher than the 1<sup>st</sup> scheme, the reasons for choosing the 2<sup>nd</sup> scheme for this project are listed below:

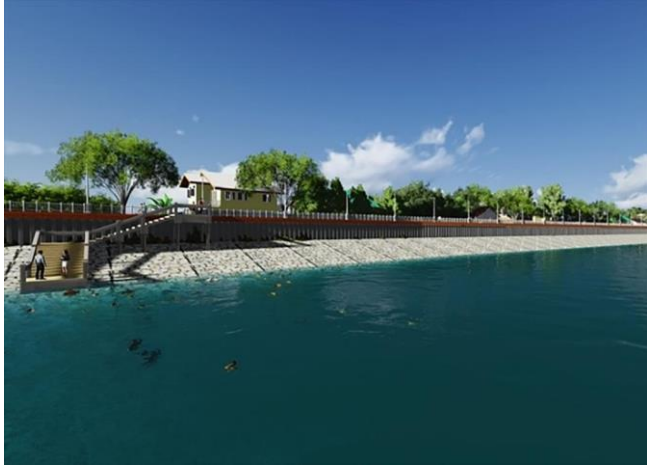
**Fig. 8.** Front view of the mitigation system.

**Figs. 8–10** illustrate the selected mitigation system. The top level of sheet pile wall was designed based on the highest water level during the flooding season. The staircases were provided as the access to the slope face for inspection and maintenance during the dry season. As mentioned earlier, the rock gabion is used in this scheme to strengthening the slope face and protecting the slope face from erosion. **Fig. 9** illustrates the ancient city walls lay behind the selected mitigation system. The pedestrian, bike lane, and the rest area were also provided for the communities as shown in **Fig. 10**. Moreover, the style of guardrails and facilities in this project were designed to be consistent with the ancient city walls and the existing structures.

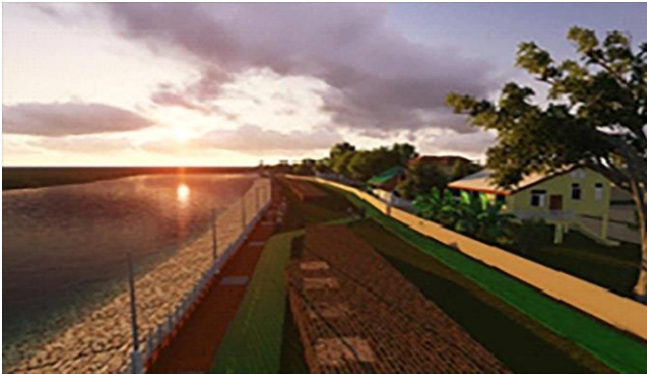
**Fig. 9.** Ancient city wall behind the sheet pile wall.

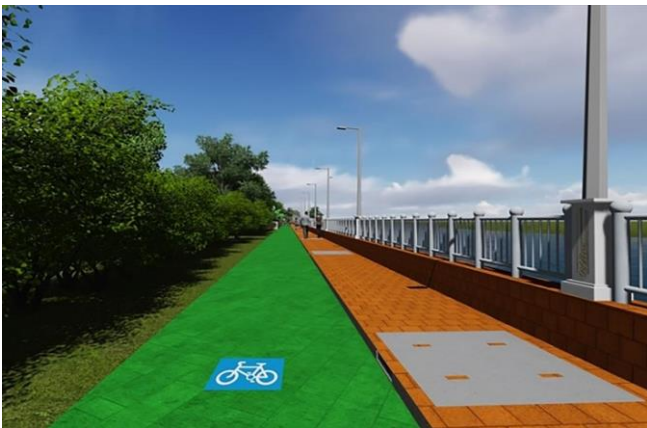
**Fig. 10.** Design for pedestrian and bike lane.
