## ANALYSIS OF STATIC MORPHOSTRUCTURE CONDITIONS WITH DYNAMIC MORFOSTRUCTURE (LANDSLIDE TYPE)

Landslides occur in many types of Tuff rocks and Tertiary-aged andesite sandstones which can cause changes in the shape of the earth's surface, which shows the development of dynamic morphostructure. The purpose of this study was to determine the relationship of static morphostructure with dynamic morphostructure landslide type in Pekuncen Banyumas District. The research method used a survey method which included fieldwork (for inventory of static morphostructure and dynamic morphostructure landslide type) and laboratory work (for interpretation of aerial and satellite photo, and analysis of static morphostructure relationships with dynamic morphostructures landslide type). The results of the study found many observable landslides and geological structures. The geological structure that contained are in the structure of folds, fractures, and volumes. There is a relationship between landslide and geological structures. In fault structures, folds and layers sloping with patterns of clustered landslide, while in volcanic structures, the patterns of landslide are spread.

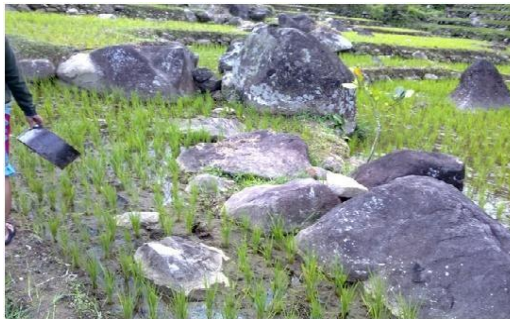
**Fig.1.** Photograph of Slamet volcanic deposits (Source: Suwarno, 2014).

The rocks type in the study area is determined based on the reading of the Geological Map of Purwokerto and Tegal Sheets, 1: 100,000 scale and the results of field observations. The results of map reading and field observations in the study area consisted of 5 rock formations. Lava sediment of Slamet Volcano (Qls) is Quaternary (Holocene) age. This formation consists of lava with volcanic rocks composed of andesite-basalt, with a diameter of 10-50 cm, produced by Slamet Tua Volcano, the distribution includes flat areas. **Fig.1** shows the Slamet Volcanic sedimentary rock.

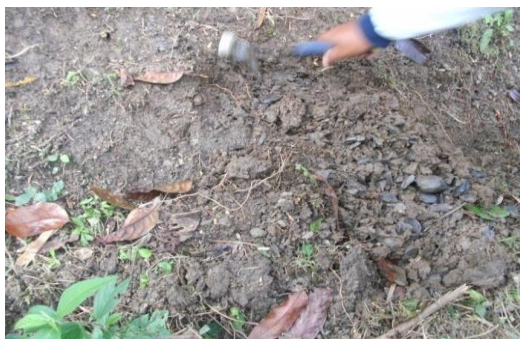
**Fig.2.** Photograph of marl rocks, (Source: Suwarno, 2014).

Slamet Rocks volcano does not decompose (Qvs) Quaternary age (Pleistocene). In this formation, there are volcanic breccia, lava, score and tuff, the distribution of which forms the terrain and hills. Tread formation (Tpt) age Tertiary (Pliocene), consisting of sandstone coarse-grained greenish, calcareous marl, greenish sandstone, calcareous tufa and marl greenery. Tertiary age (Tmph) Formation (middle-end Miocene), consisting of sandstone andesite, tuff, breccia, sand, and napal, inserts sandstones. Tertiary age (Tmr) Formation (Middle Miocene), consisting of marl. Sedimentary materials of Tertiary age from a combination of sand and clay have the highest intensity of avalanches (Luigi Borrelli, *et al.*, 2014). **Fig. 2** photos of the following marbles.

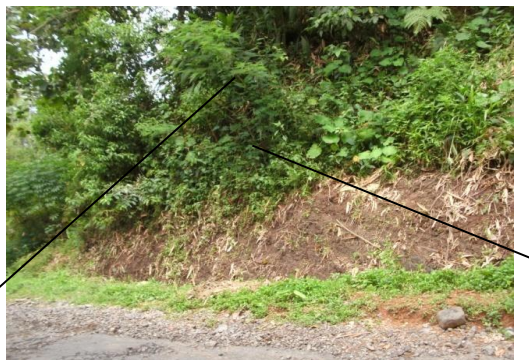
**Fig.3.** Photograph of the appearance of a fault structure (Source: Suwarno, 2014)

Outcrops of andesite sandstone are found in several locations with the direction and slope of the layers can be used to characterize the structural origin of the land, and the top layer of rock used for naming units of land. **Fig. 3** shows the layers of rock that are truncated and not in line with the slope of this slope can be used as evidence of fault structures. The appearance of the geological structure is like a fault found in Karangdlima Hamlet, Petahuan Village. Barnes & Lisle (2004) explains that to estimate the fault structure is by knowing the presence of elongated valleys, cracked rock layers that suddenly dropped. The fault is seen in the river valleys that extend along the river channel assault shown in **Fig. 4**.

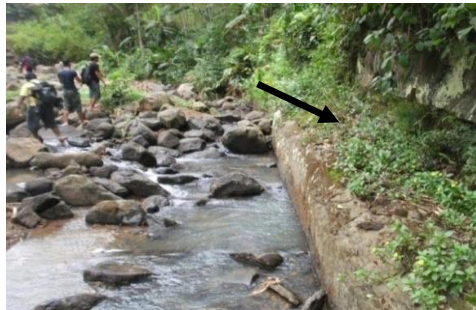
**Fig.4.** The appearance of a fault (Source: Suwarno, 2014).

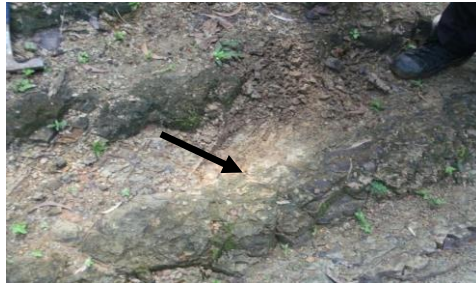
**Fig.5.** The appearance of a sloping/fold layer on Tuff rocks (Source: Suwarno, 2014)

The appearance of a sloping rock coating structure that shows the structure of the fold, for example in Klapajejer Hamlet, Cibangkong Village with a slope of  $10^\circ$  coating and  $N79^\circ E$  coating direction is shown in **Fig. 5**.

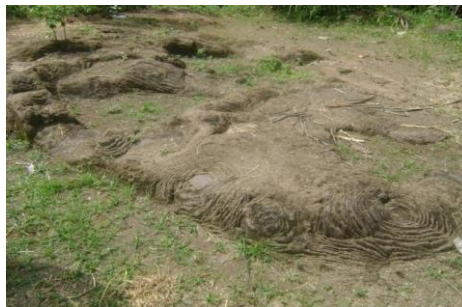
**Fig.6.** Appearance of spheroidal weathering on sandstone rocks  
(Source: Suwarno, 2014)

Verstappen (2014) explains that dynamic geomorphology studies the processes and short-term changes in the landforms depicted in dynamic morphostructure. The processes in this case are exogenous processes which consist of weathering, mass movement, erosion, and sedimentation. Weathering of rocks mainly occurs in structural forms. **Fig. 6** is an example of weathering of rounded type rocks found in a unit of structural hilly landforms of rocks sandstone, on the slope class IV in Cibangkong Village. **Fig. 7** shows the weathering process of rocks in structural landforms units of tufa rocks, on the slope class IV in Semedo Village. The process of weathering that takes place intensively will cause the weathering zone to become thicker. Weathered zones get thicker causing increased slope loads and effecting on landslide.

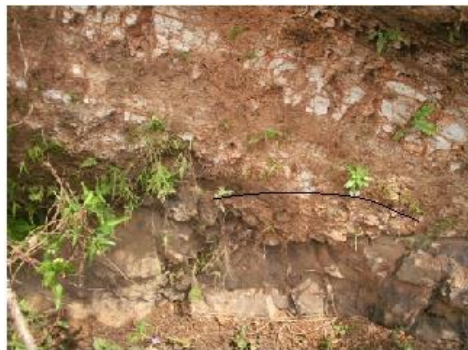
**Fig.7.** Photo of weathering appearance which is controlled by a system of cracks,  
(Source: Suwarno, 2014)

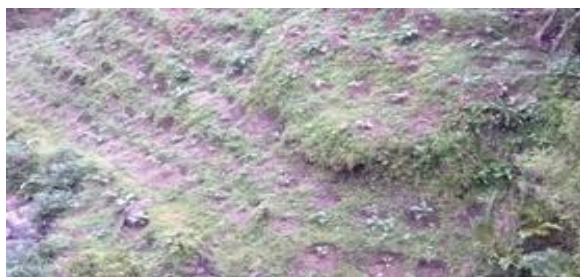
**Fig.8.** Photos of surface erosion appearance, (Source: Suwarno, 2014)

The process of erosion, especially surface erosion occurs a lot. The slope factor is one reason for surface erosion. Surface erosion is seen in units of landforms structural of tufa rocks, on slope III class in Cibangkong Village (see **Fig. 8**). These hills look bald and have only been planted with teak plants, and many surface rocks such as gravel and grit are found. Splash erosion takes place and develops to form rill erosion. Worosuprojo (2002) explains that landslides are preceded by rill erosion. Landslide is one of the most common forms of mass movement, 98 landslides were found and in the field survey in this study found the location of 98 new landslides (Suwarno, 2014). **Fig.9** is an example of a landslide appearance in the study area.

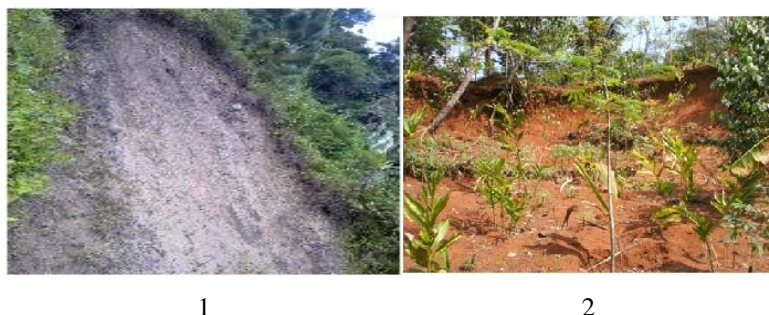
**Fig.9.** Landslide appearance photos in 1.Krajan Village, 2. Village Semedo, (Source: Suwarno, 2014)
