FACTORS INFLUENCING SOIL BEHAVIOR AND PROPERTIES OF MASS MOVEMENTS IN THE BLIMBING AREA, BRUNO DISTRICT, PURWOREJO REGENCY, CENTRAL JAVA, INDONESIA

DOI: 10.21163/GT_2022.171.03

ABSTRACT:

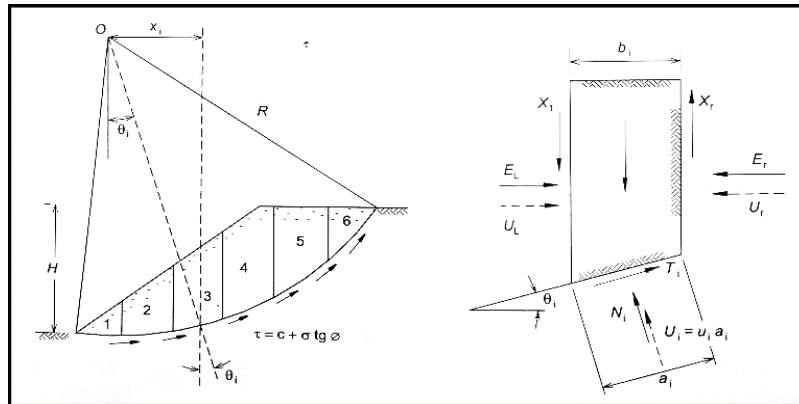
Fig. 2. Stress distribution in sliced soil slope (Rajagukguk, et.al., 2014).

The Simplified Bishop method was used in determining the safety factor of the slope formed by soil, with the assumption that the sliding plane is circular in form and the movement is rotational (Kusumayudha & Ciptahening, 2016, Kusumayudha, et al., 2020). In order to determine the type of soil mass movement, Varnes classification is used (Varnes, 1978). The RMR (rock mass rating) method is used to analyse slopes composed of rocks (Bieniawski, 1989), as well as the Markland Method (Citrabhuwana et al., 2016). The Simplified Bishop Method uses Limit Equilibrium and utilizes a sectional approach where the forces acting on each slice are shown as in **Fig. 2** (Rajagukguk et al., 2014). In the RMR assessment, **Table 1** and **Table 2** were used (Bieniawski, 1989).

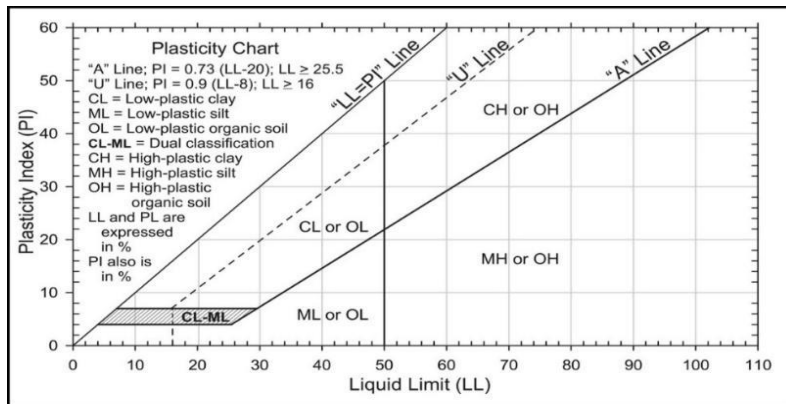
Fig. 3. Casagrande Diagram (ASTM D-2487).

In determining the plasticity index (PI) of soil, the interpretation of the plastic and liquid limits is carried out using the Casagrande diagram (Fig. 3). To classify the soil type, it uses the American Association of State Highway and Transportation Officials (AASHTO) naming system (Hardiyatmo, 2014). Expansive properties, expansive soils, and swelling potentials are used to indicate soils that are prone to shrinkage and contain a lot of clay, especially the mineral of montmorillonite (Hardiyatmo, 2014). Based on their expansive properties, there are three groups of clay minerals (Nelson & Miller, 1991), namely kaolinite, non-expansive, mica-like, for example, illite and vermiculite, which can be expansive, and mildly developed illite, the smactite group, including montmotillonite, which is highly expandable or expansive (Duncan & Fasce, 1995).

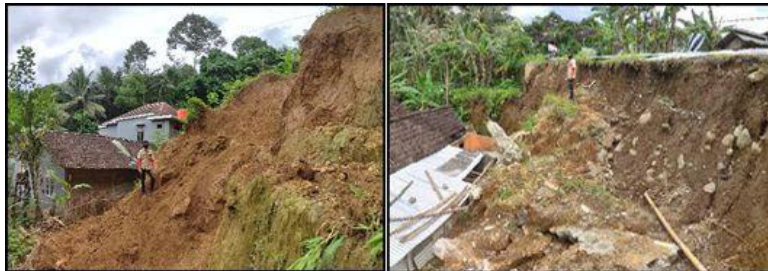
Fig. 6. Slope 1 (LR 1), left, and Slope 2 (LR 2), right.

Mass movements in the study area can mostly be classified as landslides. Although most of the mass movements in the study area involve weathered soil, in some locations the slopes are composed of rock, and they also often have the potential to fail. In this study, seven representative slopes comprising soil, coded as LR1, LR2, LR3, LR4, LR5, LR6, LR7 (**Fig. 6 to Fig. 9**), and one slope consisting of rock (LR8), were analysed. The selection of the studied slopes is based on their potential threat to settlements and/or public roads if they move.

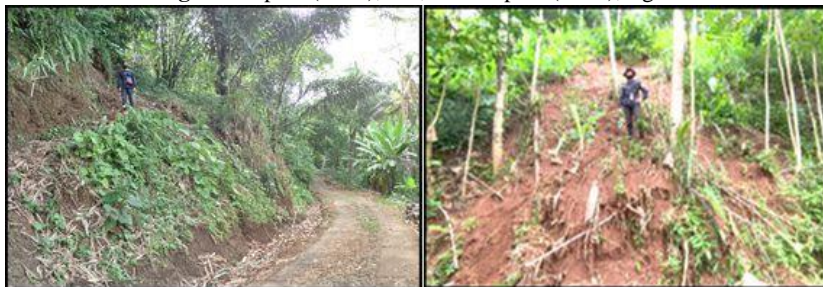
Fig. 7. Slope 3 (LR 3), left, and Slope 4 (LR 4), right.

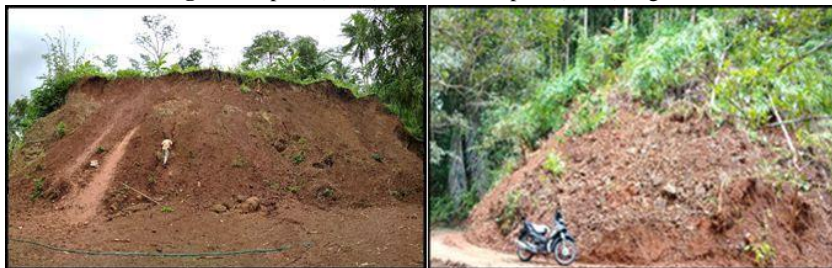
Fig. 8. Slope 5 (LR 5), left, and Slope 6 (LR 6), right.

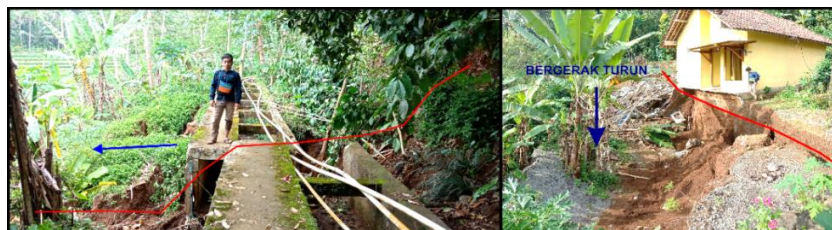
Fig. 9. Slope 7 (LR 7), and the direction of movement (blue arrow).

7	Tegalsari village, main road side Kutoarjo – Bruno 385599 mE 9163143 mN	Threatening 12 houses, sloping 37°, slope length 78.3 m,	Tuffaceous sandstone of Halang Fm, intensively weathered, wet condition,	MH, high plasticity, silt, A-7-5 (22), $\gamma = 1530,8$ kN/m ³ Expansive clay, illite	C = 14 kN/m ² ; $\phi = 30^\circ$ W = 77.1% K = 3.4 x 10-4 cm/s	Fs = 0.961 Slump (Landslide) Slide direction

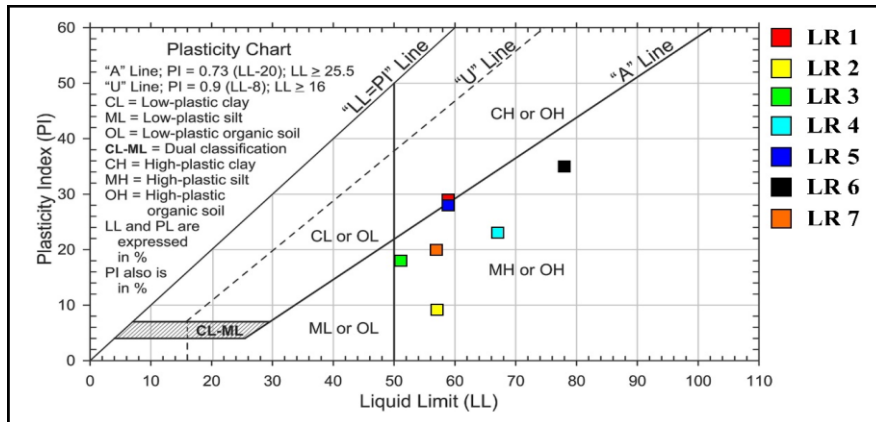
Fig. 10. The plots of liquid limit and plasticity index from LR1 to LR7 are used to determine the soil type. It shows that most of the soils are included in MH (high-plastic silt) or OH (high-plastic organic soil), except for LR1 and LR5, which belong to CH (high-plastic clay).

The results of the soil consistency test in the form of plasticity index (PI) and liquid limit (LL) values were then plotted into the Casagrande diagram for determining the soil type (**Fig. 10**).

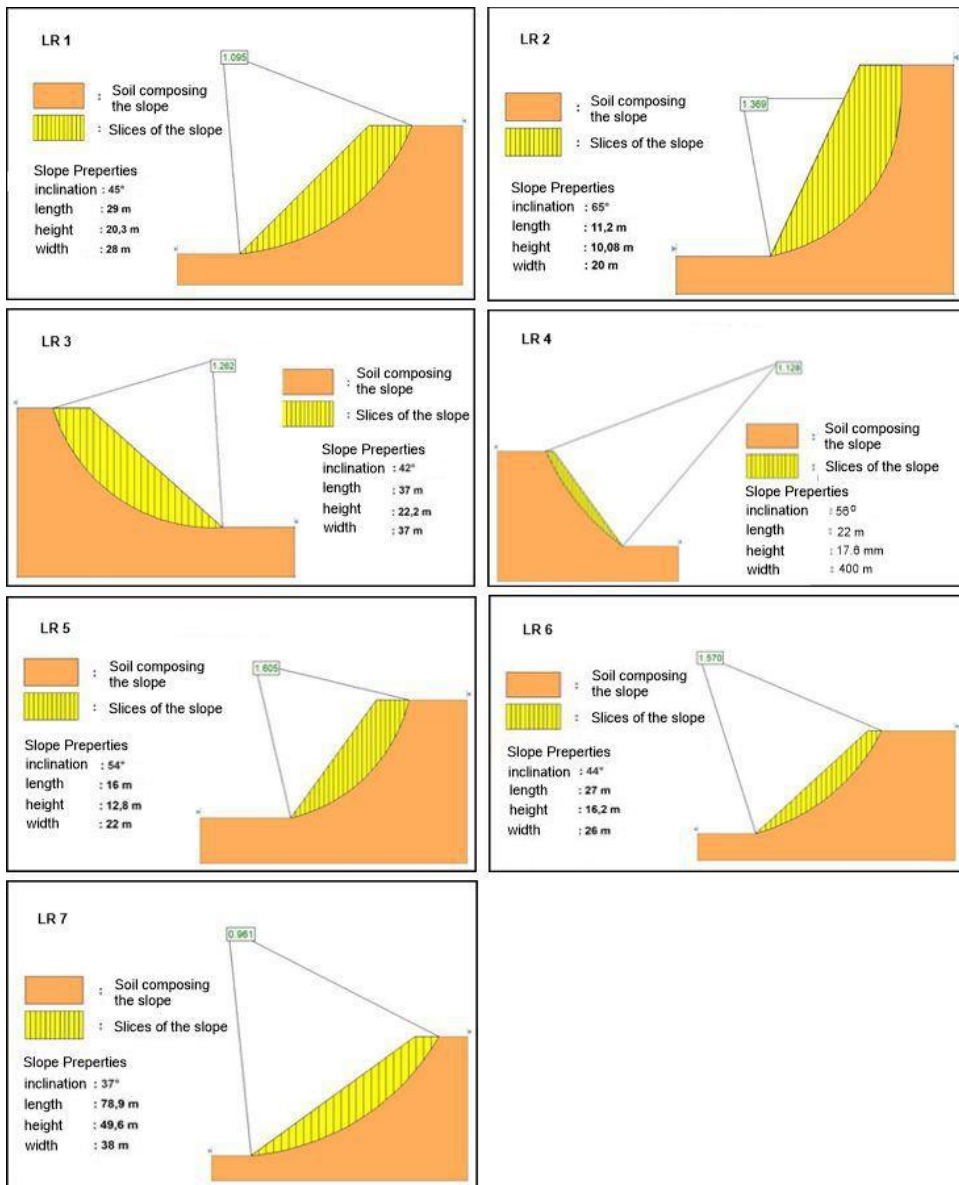
Fig. 11. Model of mass movements and factor of safety determination in the study area.

The expansive nature of soil depends on the type of clay content in it. By approaching ASTM (Chen, 1975; Nelson & Miller, 1991) from the value of the plasticity index (PI), the expansive properties of soil can be known (**Table 6**). Table 6 shows that in all of the representative slopes being studied, the types of soil constituents are very expansive, having the potential to expand, and some of them contain smactite clay. This is reinforced by the results of petrographic analysis of the Halang tuffaceous sandstone unit, which shows the large content of volcanic material, especially plagioclase. It is known that when plagioclase undergoes weathering, clay minerals will be formed. On the 7 representative slopes, the determination of the safety factor was carried out using the simplified bishop method (**Fig 11**). The overall results are described in detail in **Table 7**.

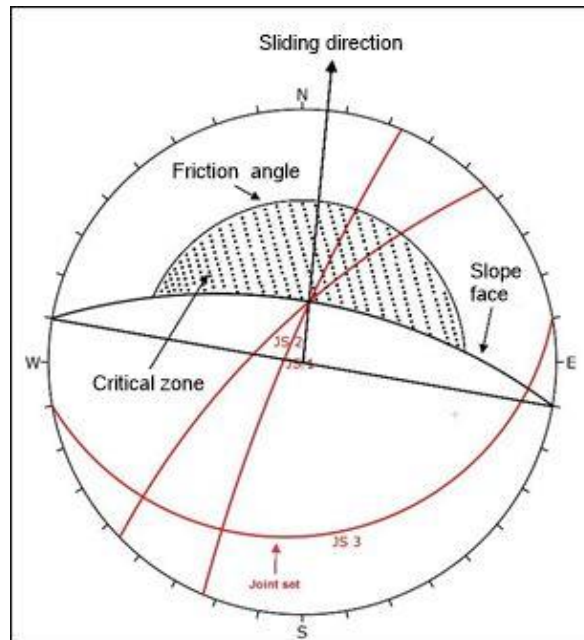
Fig. 12. The stereonet plot of LR 8, showing failure potencies of wedge type through the interception of JS2 and JS4, and toppling through JS 3.

There are discontinuity planes at this location with the strike and dip of joint set 1 (JS1) N203°E/82°, joint set 2 (JS2) N226°E/72°, joint set 3 (JS) N80°E/21°, the slope face is N280°E/63°, and the friction angle is 25°. The plot of this data for Markland analysis is shown in **Fig. 12**.

The result of the stereonet plot and markland analysis demonstrate that the slope is not safe and the type of landslide potential is wedge and toppling failures. As well as the strike of the discontinuity plane, which is represented by the joint set of 3 forming an angle of 20° toward the strike of the slope, so that it will form a toppling landslide.

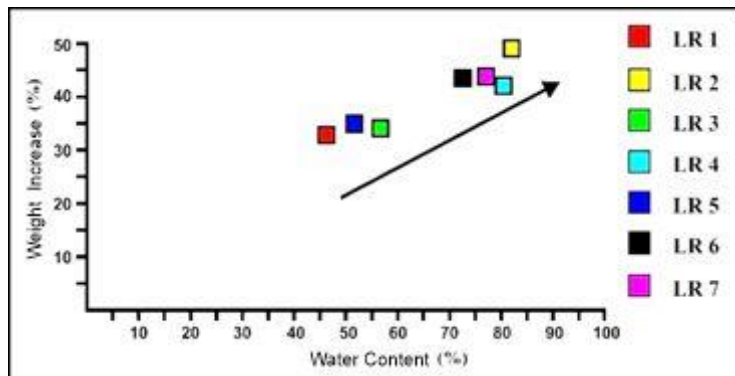
Fig. 13. The plots of water content and percent weight increase of the soil sample, showing the correlation of water content and weight increase. The higher the water content, the greater the percentage of the soil weight increase.

The soil cohesion (c) values of the investigated slopes range from 8 KN/m² to 25 KN/m², and the internal friction angle (ϕ) values extent from 20° to 49°. The types of soil are high plastic clay and high plastic silt with slightly expansive potential to very expansive, so that it will cause swelling when the water content is high and be able to form cracks if it loses its water content. The permeability ranges from 3.410^{-4} to 5.510^{-5} and the water content ranges from 46.35% to 80.47%. This shows that the speed of water movement in the body of the slopes is very low. With this very slow motion, the presence of water in the soil will cause hydrostatic pressure in the pores of the material. In turn, this condition will increase the weight force, reduce the cohesion force (c) value, and reduce the friction angle (ϕ) (Fig. 13, Fig. 14, Fig. 15), thereby increasing the potential for mass movements in the area.

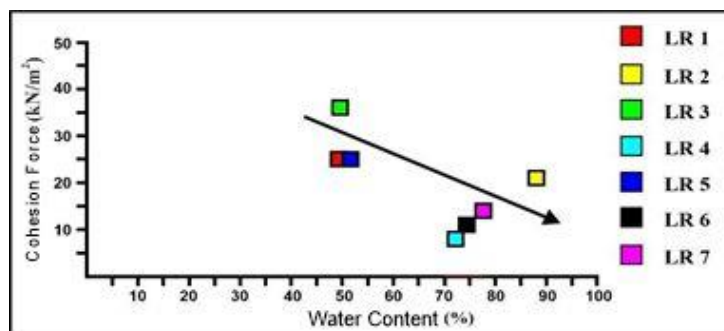
Fig. 14. The plots of water content and cohesion force value of the soil sample, showing the correlation of water content and cohesion force (c). The higher the water content, the lower the cohesion force.

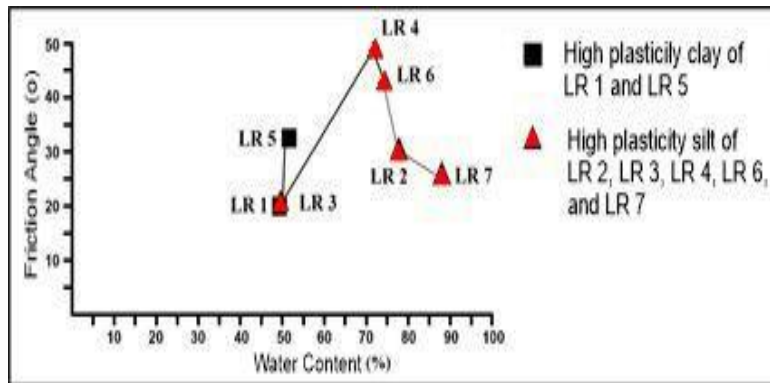
Fig. 15. The plots of water content and friction angle (α) value of the soil sample, showing that when the water content is higher than 70%, the friction angle will decrease.
